PLATE 2

Vaca Mountains Segment

Annotations by Knuepfer (1977)

Annotations by Bryant (this report). Underline in green, rather than box, indicates response or modification to observations of Knuepfer (1977).

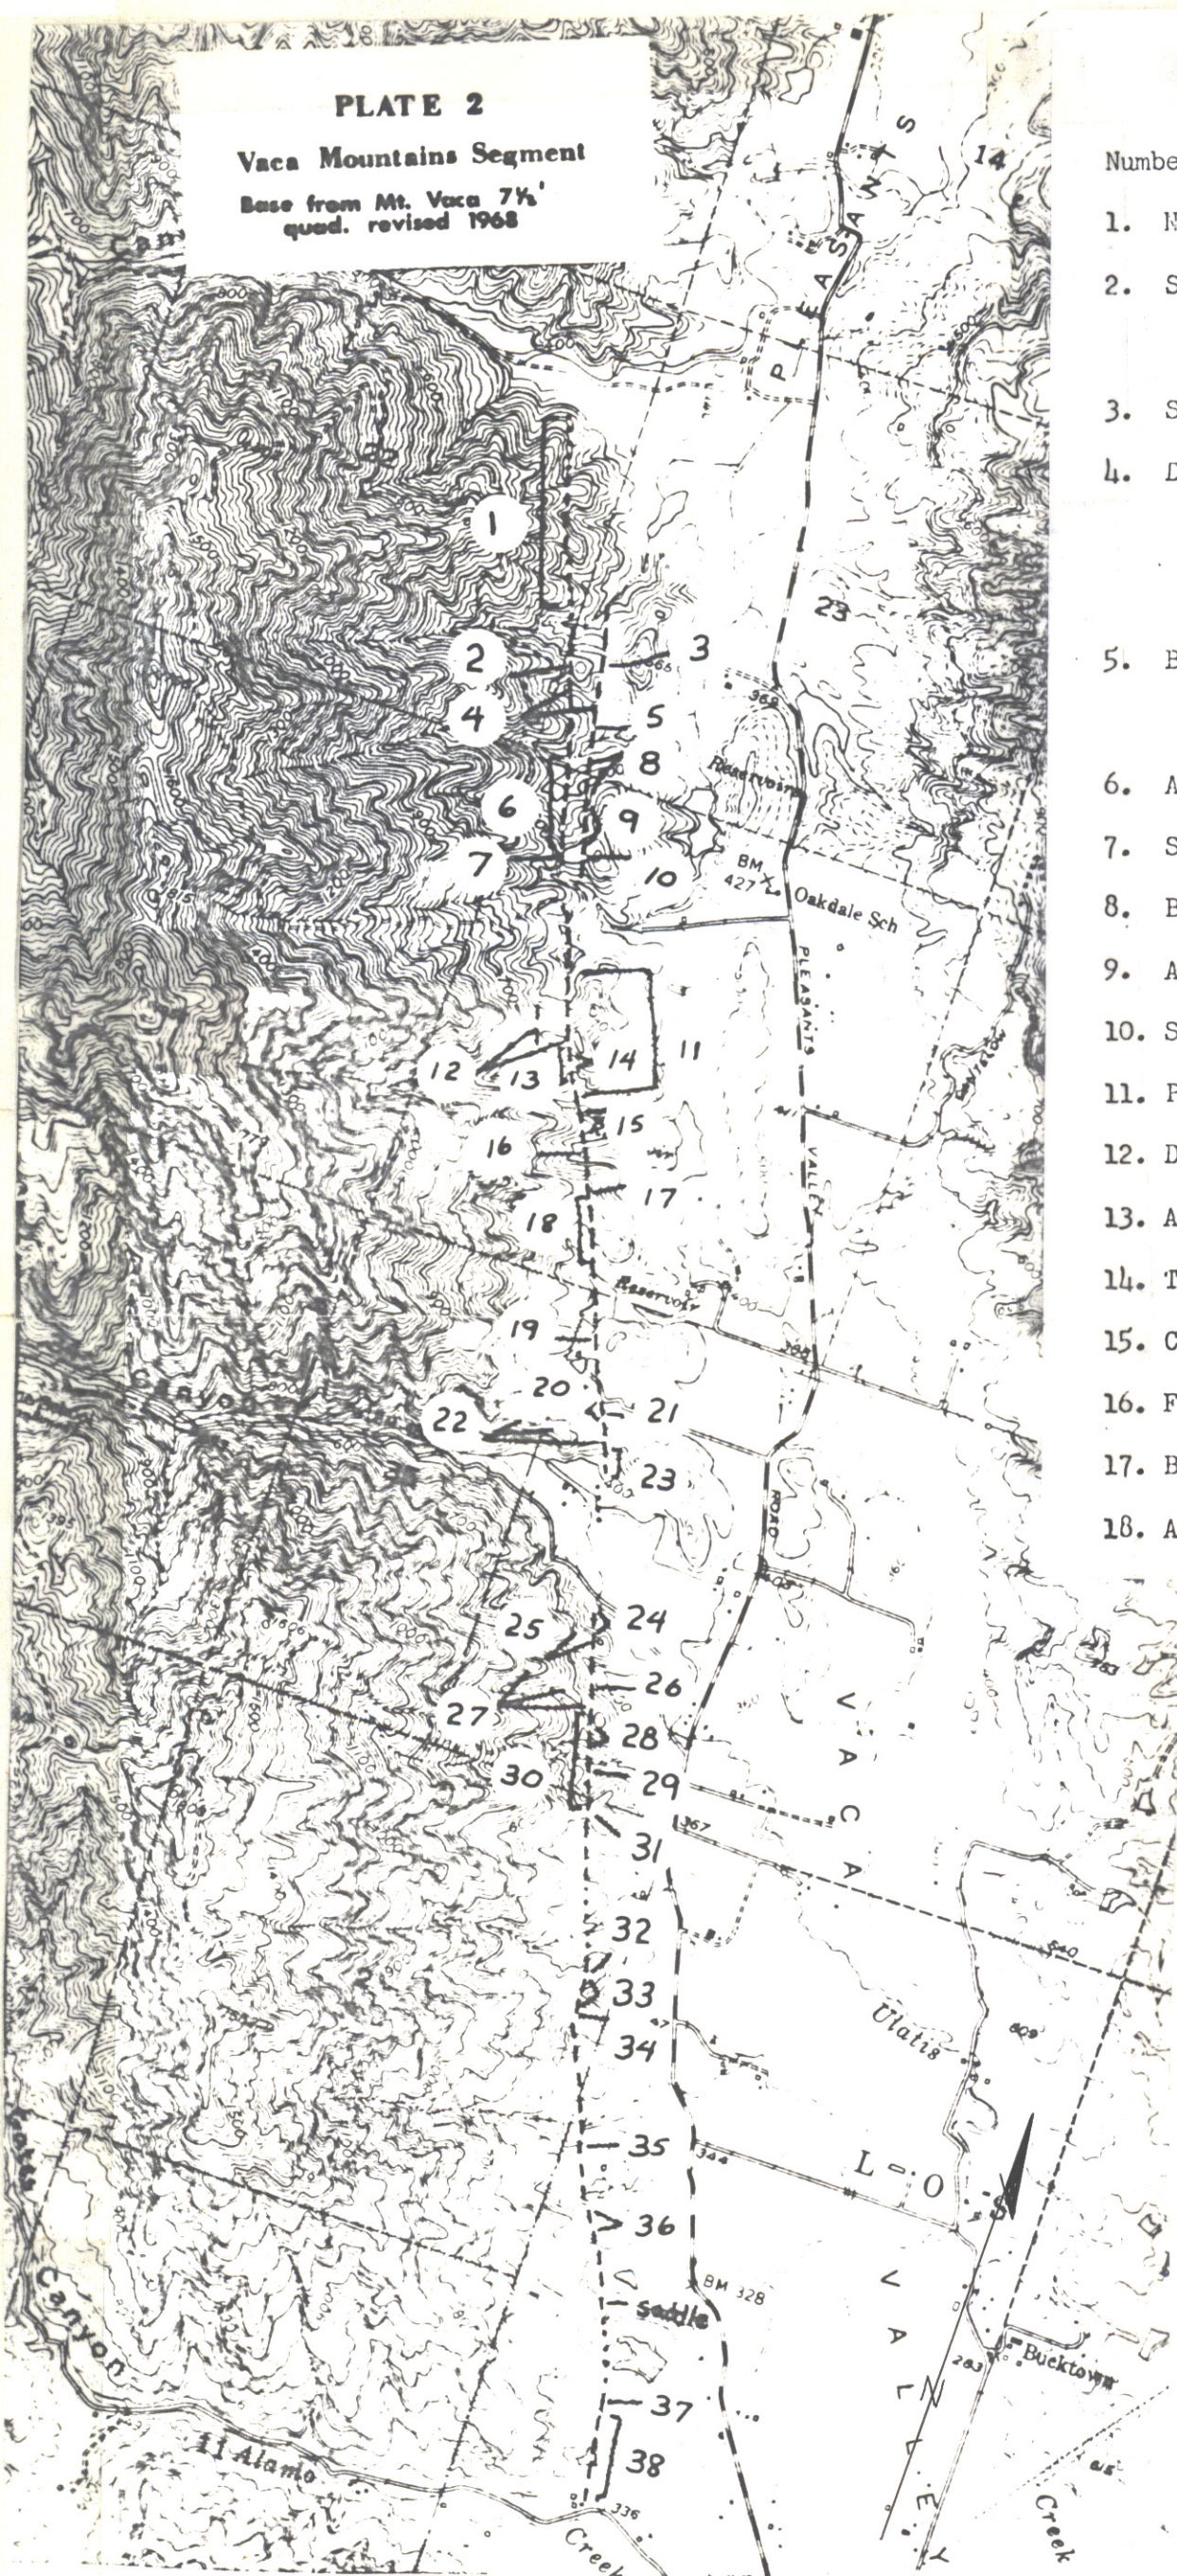
1. No consistent features ✓
2. Saddle on ridge. Drainage is clearly aligned on south side of ridge but only approximately aligned on north side.
3. Saddle ✓

4. Deflected drainage. Secondary east-flowing drainage channel is - due to bedding deflected southeast, thence turns back to original eastward direction. Total deflection 30 m over distance of 75 m.

5. Beheaded drainage. Shallow drainage channel is beheaded at buried telephone cable. ? can't see - perhaps man-made
6. Aligned drainage or swale. - bedding

7. Saddle or notch. ✓
8. Broad double bench. ✓
9. Aligned swale. ✓ bedding?
10. Saddle. ✓
11. Poorly defined tree alignment. ?
12. Double saddle (two parallel saddles).

13. Alignment of drainage. - strongly influenced by bedding
14. Tree alignment. ?
15. Channel deflected by fallen tree.
16. Flattening of drainage channel. - by Qls?

17. Broad saddle. ✓
18. Aligned swale. ? probably just deflected drainage caused by resistant ridge
19. Broad saddle. ✓
20. Bench, 2 to 3 m wide. - probably extension of resistant bed

21. Drainage is incised 1 to 2 m, extending headward to bench; above bench drainage is confined to broad swale. - drainage deflected by resistant bed
22. Saddle. ✓

23. Poorly aligned drainage. ✓
24. Aligned tree line and swale. - sharp tonal lineament just north of #24
25. Double saddle. ✓
26. Multiple saddle sequence rising to 1000 ft elevation. ✓

27. Bench. ✓
28. Linear gully, 100 m long. ✓
29. Flattening of drainage channel. ✓
30. Vegetation contrast and alignment visible on 1937 photographs, but not now apparent in field.

31. Saddle. ✓
32. Saddle. ✓
33. Tree alignment. ? not parallel to mapped fault - probably bedding
34. Saddle 5 m east of projection of tree alignment.
35. Saddle. ✓

36. Saddle. ✓
37. Saddle. ✓
38. Aligned drainage channel. ✓ developed because of resistant ridge striking parallel to inferred fault
